WT-65

This volume is the report of a test program to measure under carefully controlled conditions on the ground the effects of an atomic bomb on aircraft and missile structures. Some measurements of the blast and thermal phenomena peculiar to the USAF problem are included.

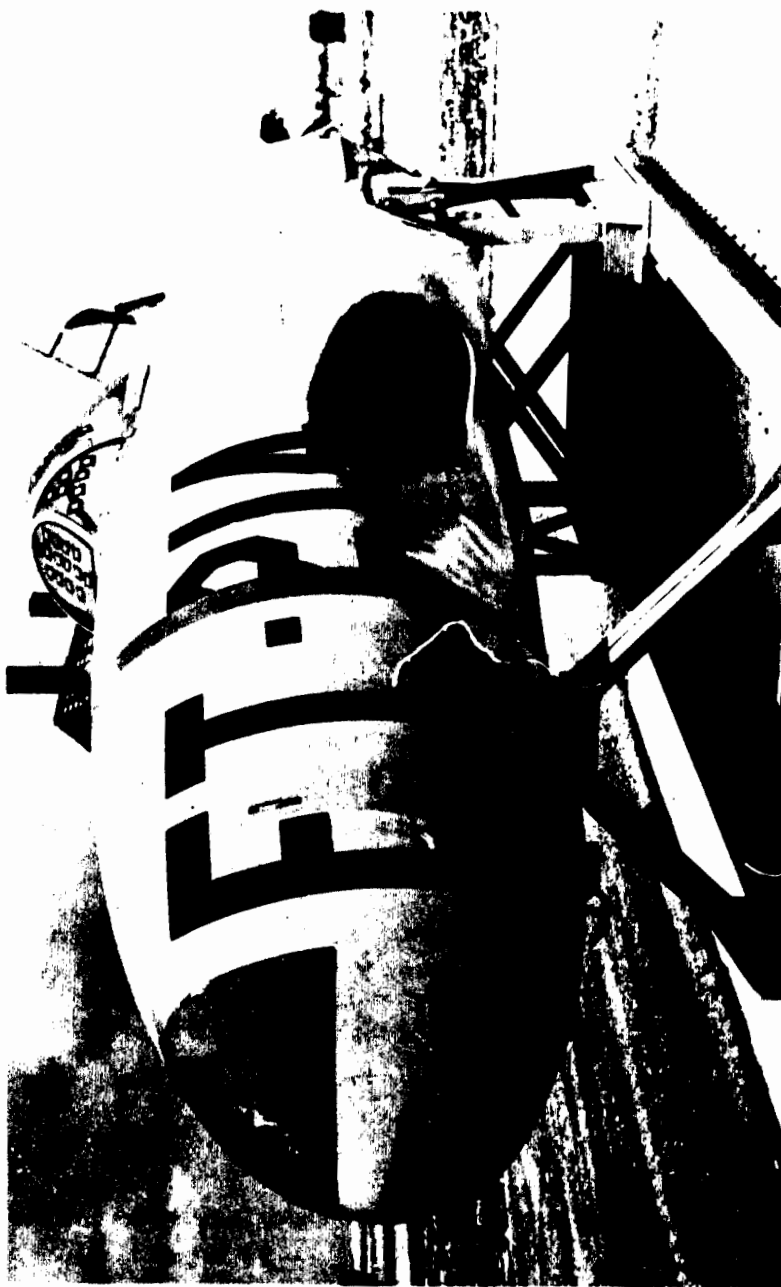
Fig. 2.22 F-80 Fuselage on Muzin after Detonation. Scorching of the radar dome and paint on leading edge of air scoop was the only perceptible damage.

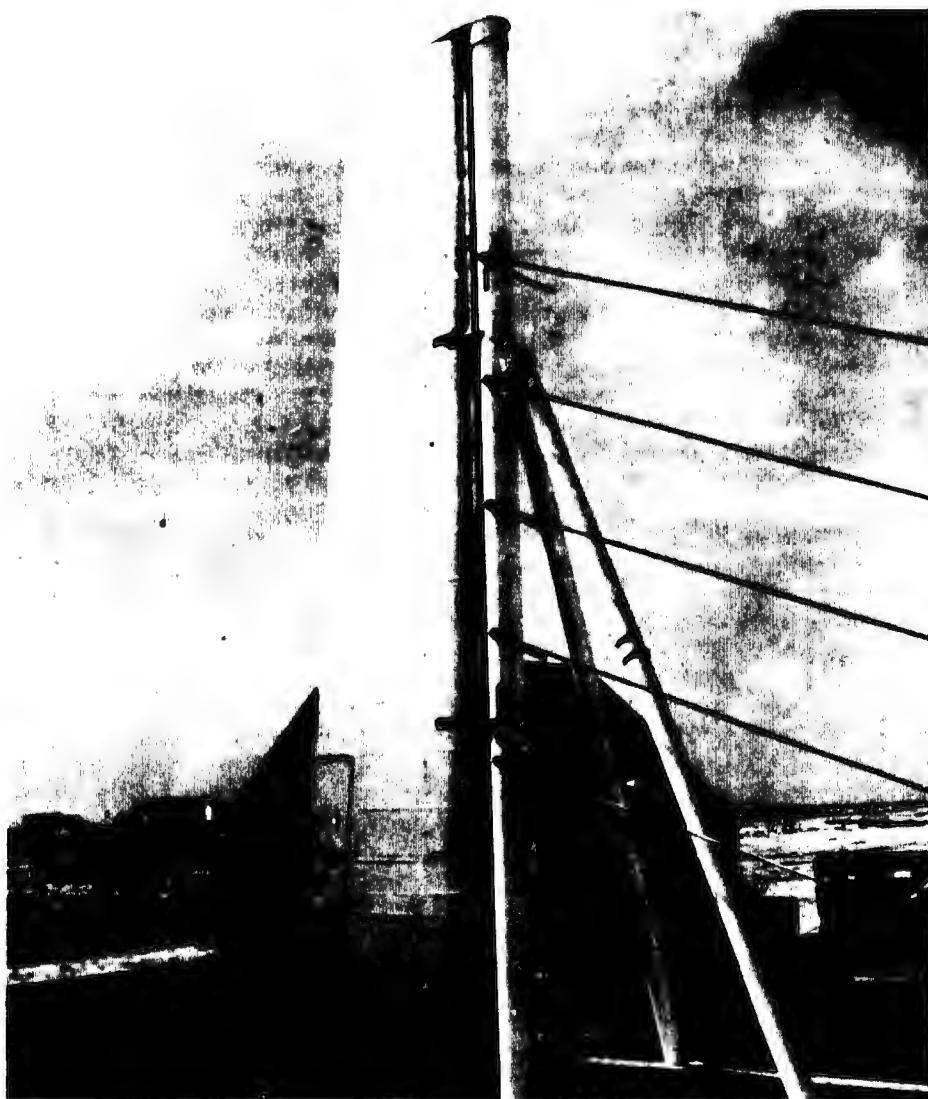
**Fig. 2.23 B-17 Elevator Installation, Engebi, Range 4,020 Ft, before Bomb Burst**

The effects of differential pressure due to an atomic bomb blast were observed on aircraft control surfaces, which are relatively fragile sections compared to the main structure of the aircraft. Both fabric-covered and metal-covered surfaces were exposed. The fabric-covered surfaces were B-17 elevators mounted vertically on tubular steel supports which were bolted to heavy steel beams anchored to a reinforced-concrete base (Figs. 2.23 to 2.27). The elevator consisted of an aluminum-alloy structure covered with aircraft fabric and doped with a silver finish. The part used was a standard B-17 elevator issued from Air Force stock. The metal-covered control surfaces consisted of standard Air Force stock ailerons and flaps mounted in a normal flight attitude ( $0^\circ$ ) on the trailing edges of the F-47 wing panels discussed in Sec. 2.4.11. Both the metal-covered and fabric-covered control surfaces were oriented parallel to the direction of blast propagation in order that any damage sustained would be due to differential-pressure crushing and not to side-on loading. The B-17 fabric-covered elevator was somewhat shielded from the high-temperature thermal radiation by the  $6\frac{1}{4}$ -in.-diameter supporting tube, as may be noted in Fig. 2.23.

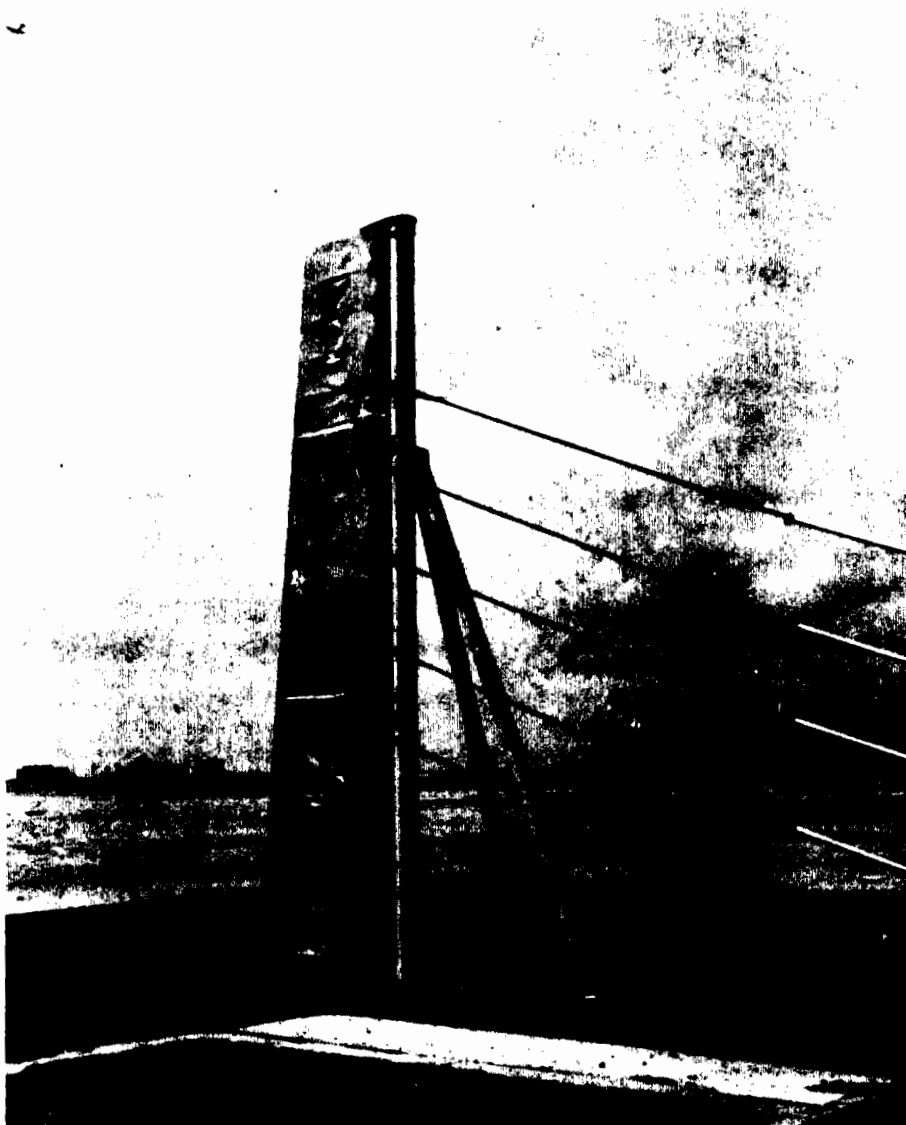
Fig. 2.24 Structural Damage Sustained by B-17 Elevator on Engebí after Detonation. Compare with Fig. 2.23. Note small hole in fabric in Fig. 2.23 in same bay where fabric is torn in this picture.

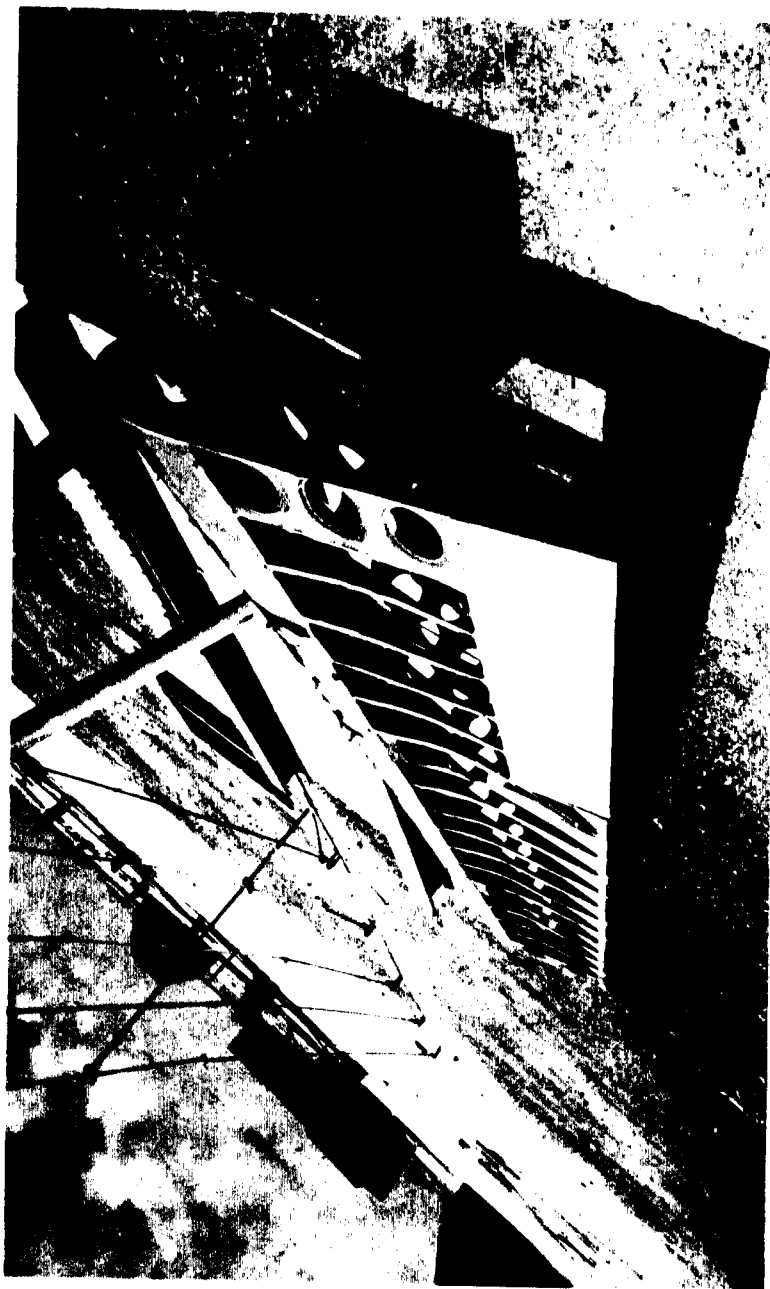
Fig. 2.25 Spanwise View of B-17 Elevator from Engeb1 with the Fabric Removed from One Side (after Detonation). The concave appearance of all the crushed ribs is shown.

The elevator on Engebi was damaged considerably, although the outward appearance belittled the actual damage that had occurred to the internal structure (Fig. 2.24). The doped fabric skin which was fairly well shielded by the supporting tube was scorched or burned through in places on the upper-surface leading-edge portion. The fabric skin on both sides was loose and wrinkled, with a small torn place on the upper surface between two ribs. This torn place may be directly attributed to the extension of a small hole ( $\frac{1}{8}$  in. diameter) that was in the fabric at this point prior to the test. Close examination of the contour of the elevator indicated that the shape was changed and therefore a probable crushing of the internal structure had occurred (ribs). The impression of the ribs on the metal skin of the trim tab was also evidence of damage due to crushing. The elevator was dismounted, and practically all the doped fabric skin was removed from one side to allow observation of the internal structure (see Fig. 2.25). The crushed metal ribs

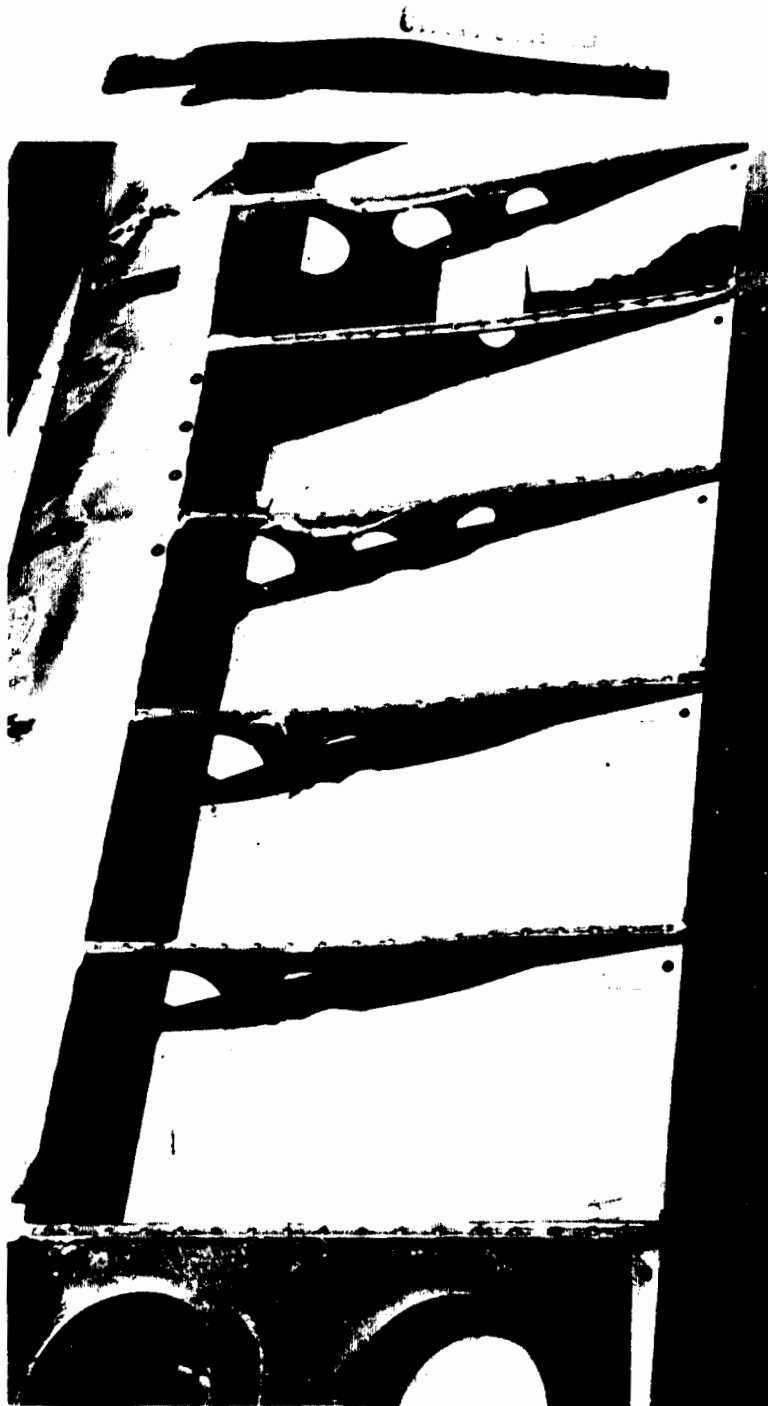
Fig. 2.26 Crushed Internal Structure of the Inboard End of the B-17 Elevator, Engebl, 4,020 Ft, after Detonation

of the internal structure and burned sections of skin may be seen in Figs. 2.26 and 2.27.

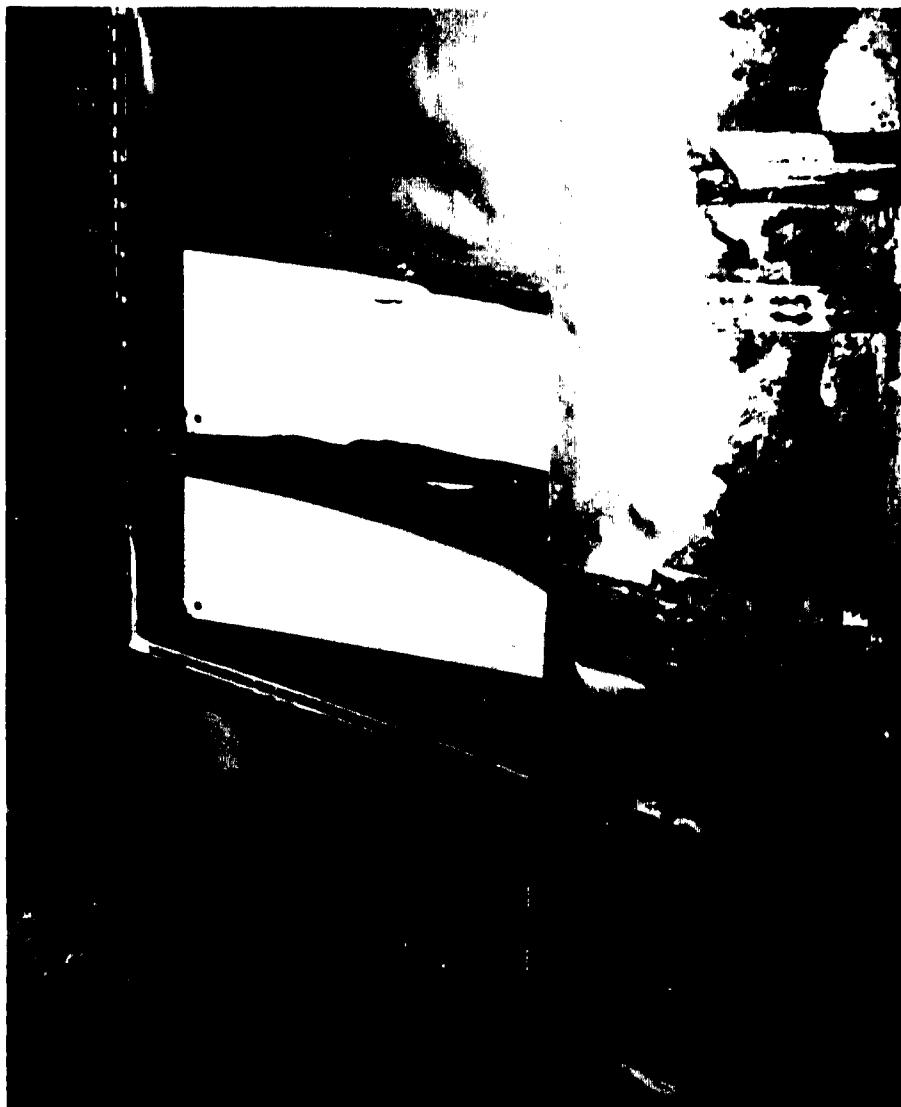
**Fig. 2.27 Inboard Portion of the B-17 Elevator Showing Burned Fabric at the Leading Edge and Crushed Structure (after Detonation)**

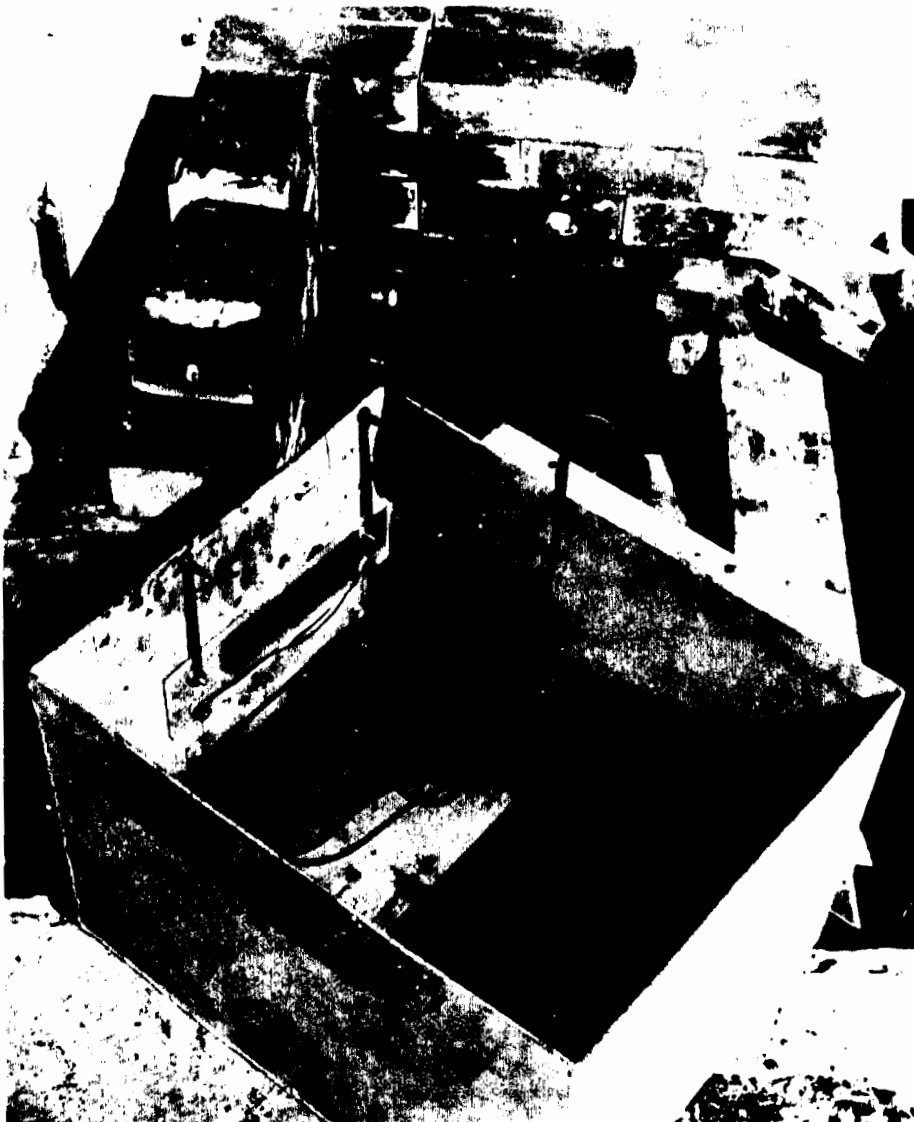
**Fig. 2.29** Fastax Camera with Protective Canister (before Bomb Burst). Plexiglass cover exit pupil and the placement of some lead bricks are shown.

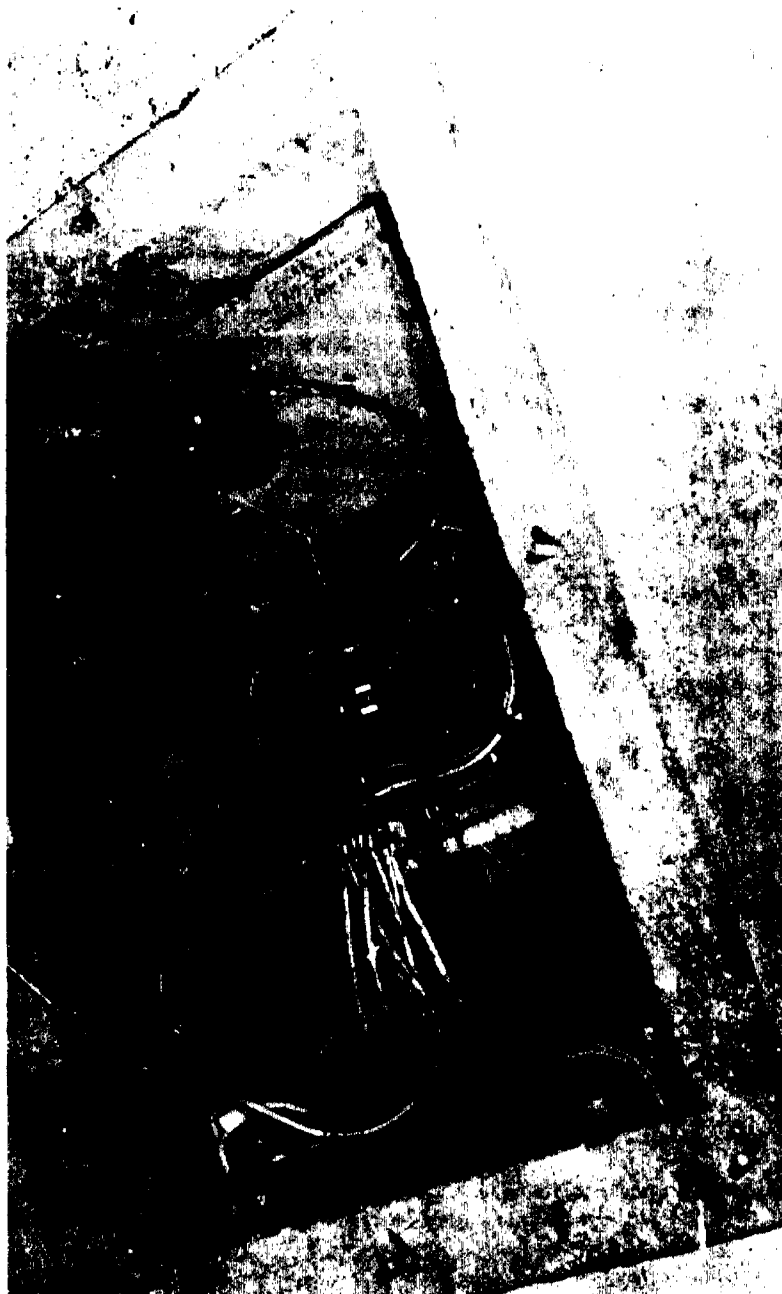
Fig. 2.32 Typical Electrical Controls at Each Island Site for Cameras and Lights, before Detonation

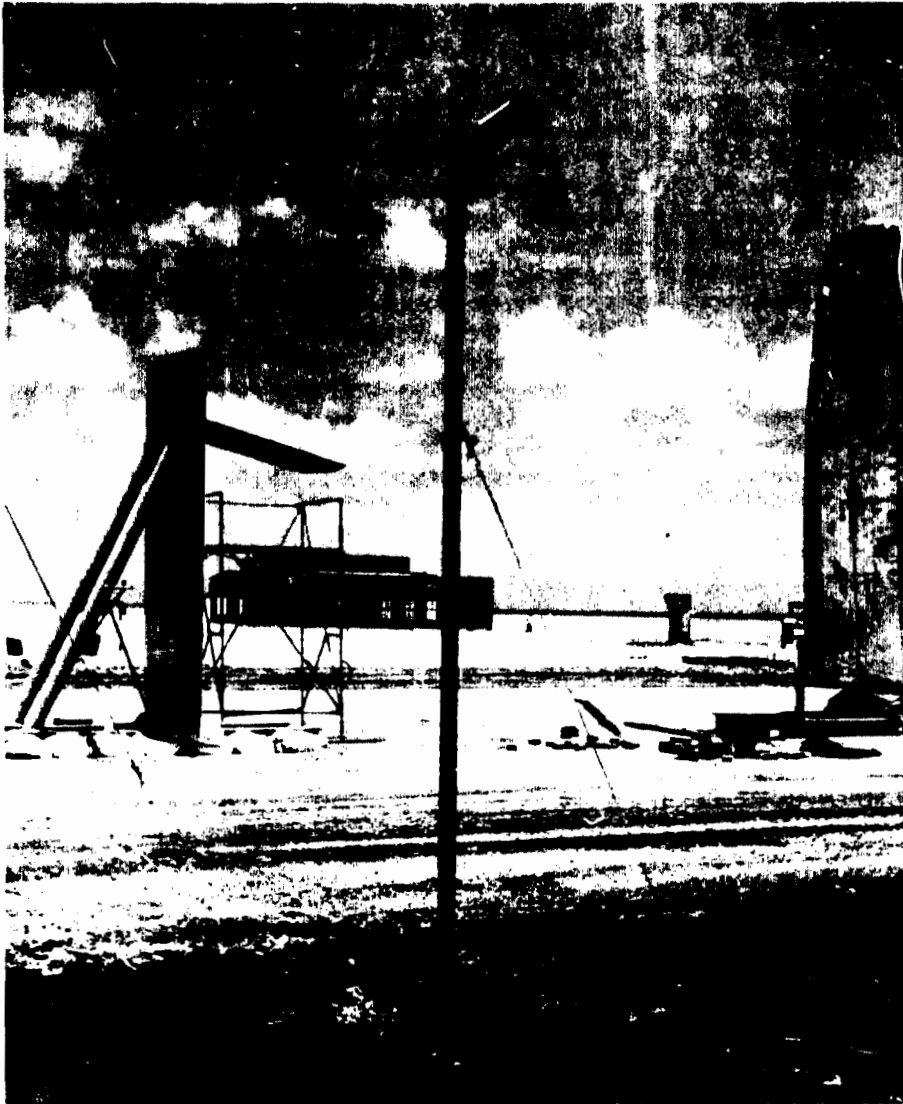
**Fig. 2.33** Installation of Angle-of-attack Blast Switch for Simultaneously Triggering Electronic Chronographs, Muzin, before Detonation. The chronographs were housed in submerged concrete instrument shelter.

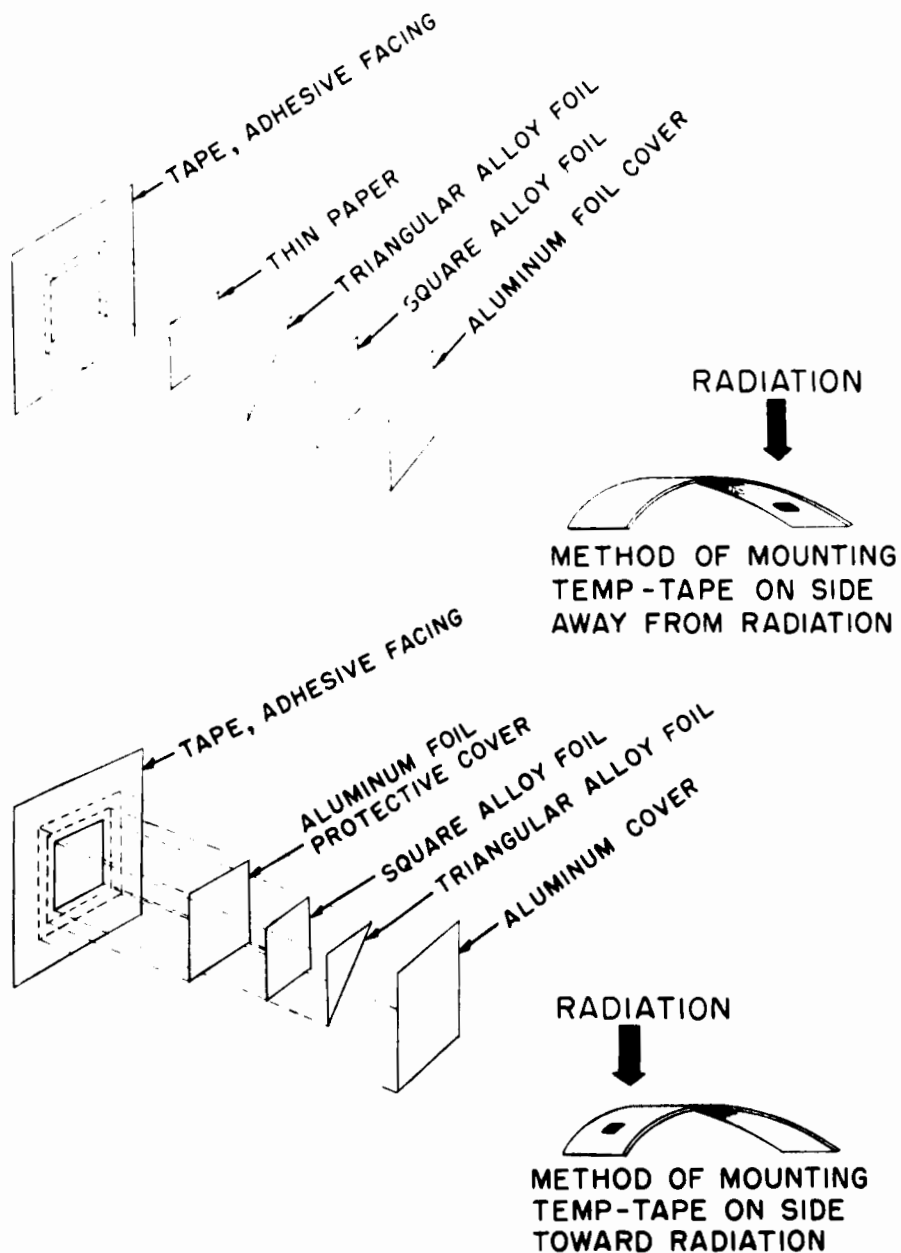
Fig. 3.7 Drawing of Temp-Tape Components

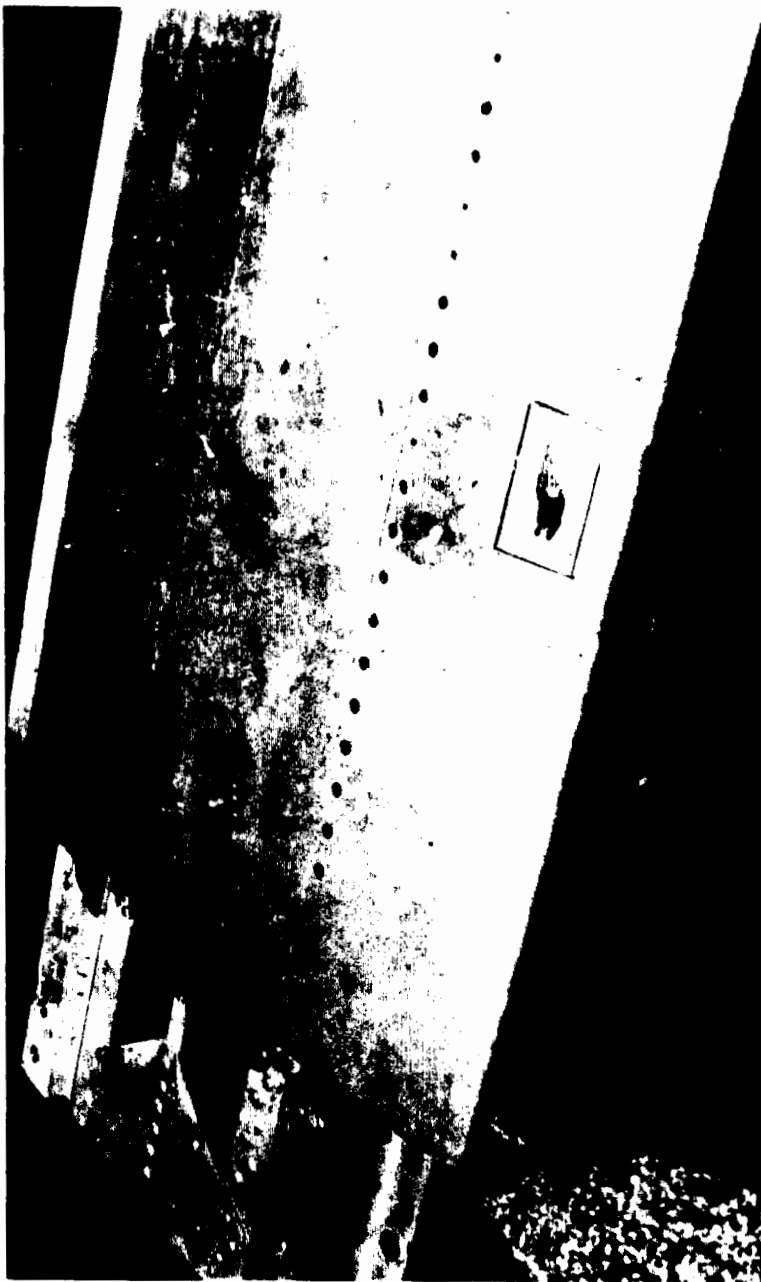
Fig. 3.8 Outside-skin-surface Temperature vs Time Gauge Installed on Bottom Surface of a -04 Structural Wing. See pencilled rectangle. Gauge sensing element, to the right of the dark patch, was covered with aluminum paint. Relative absorptivity of gauge and wing skin is indicated by their relative shading.

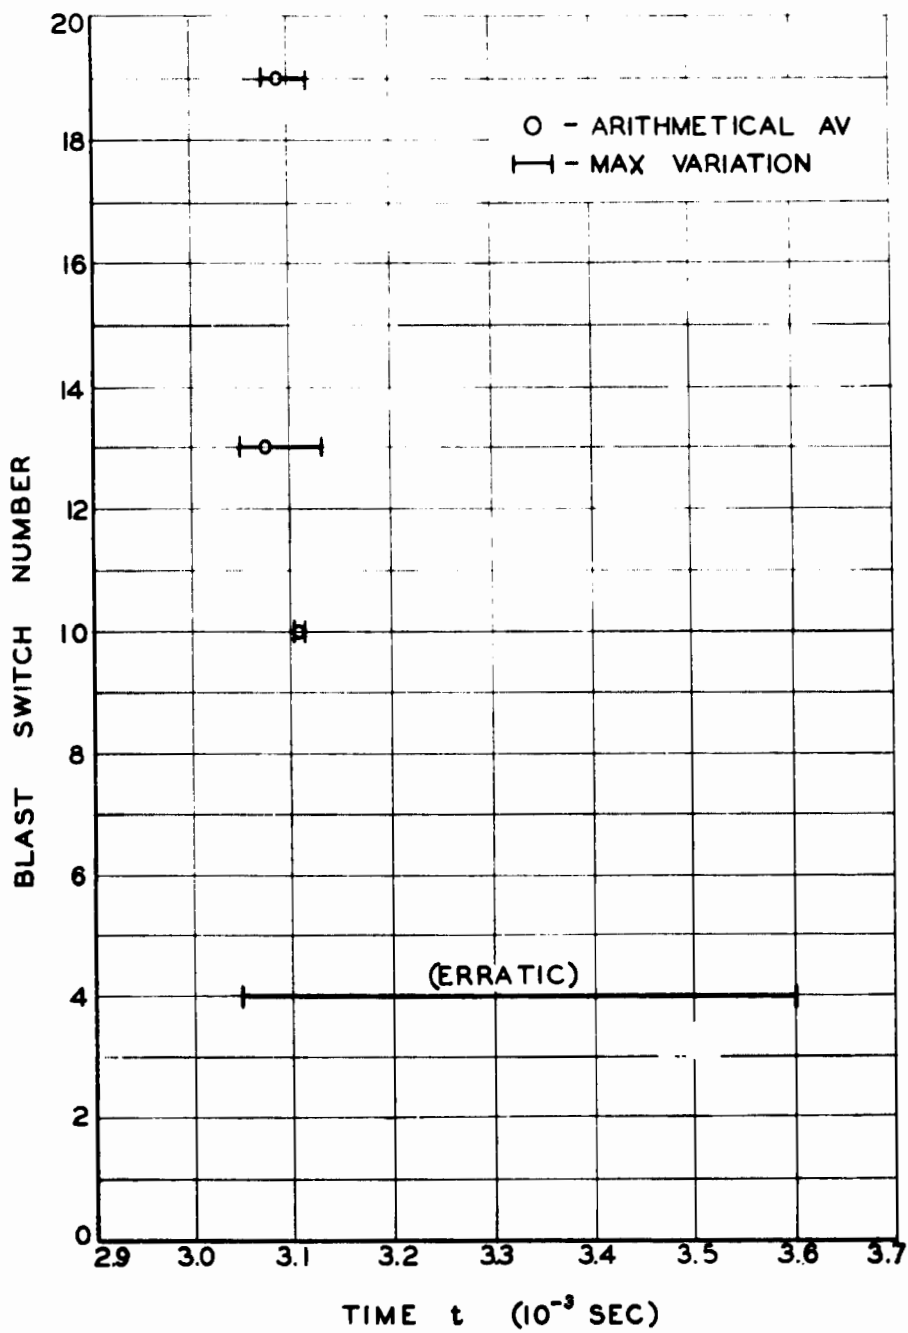
Fig. 4.1 Calibration of Blast Switches

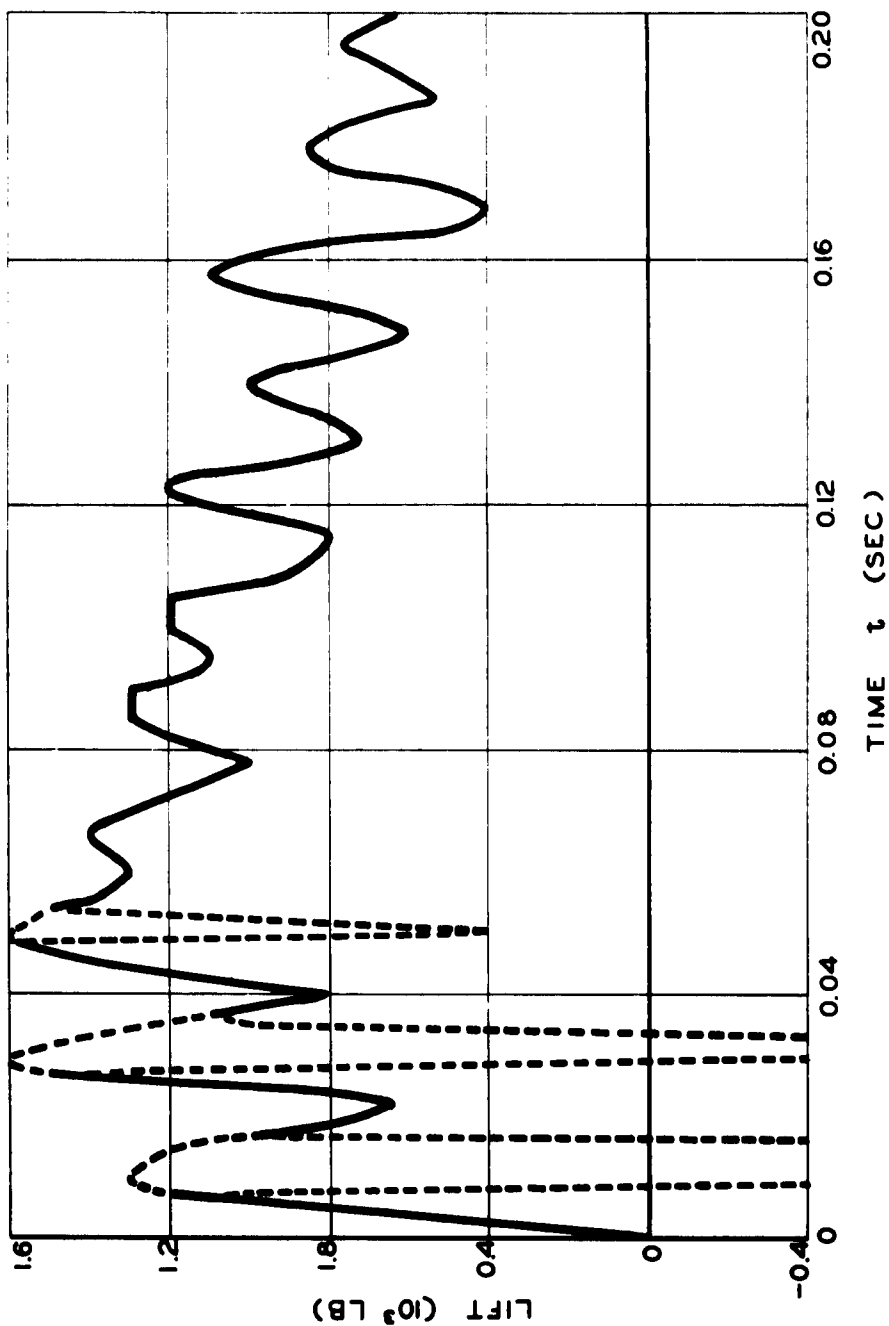
Fig. 5.8 Variation of Lift with Time, Obtained from Balance-system Measurement for Rigid Wing 102.  
The angle of Incidence was  $9^\circ$ , and the range was 4,020 ft, Engbl.

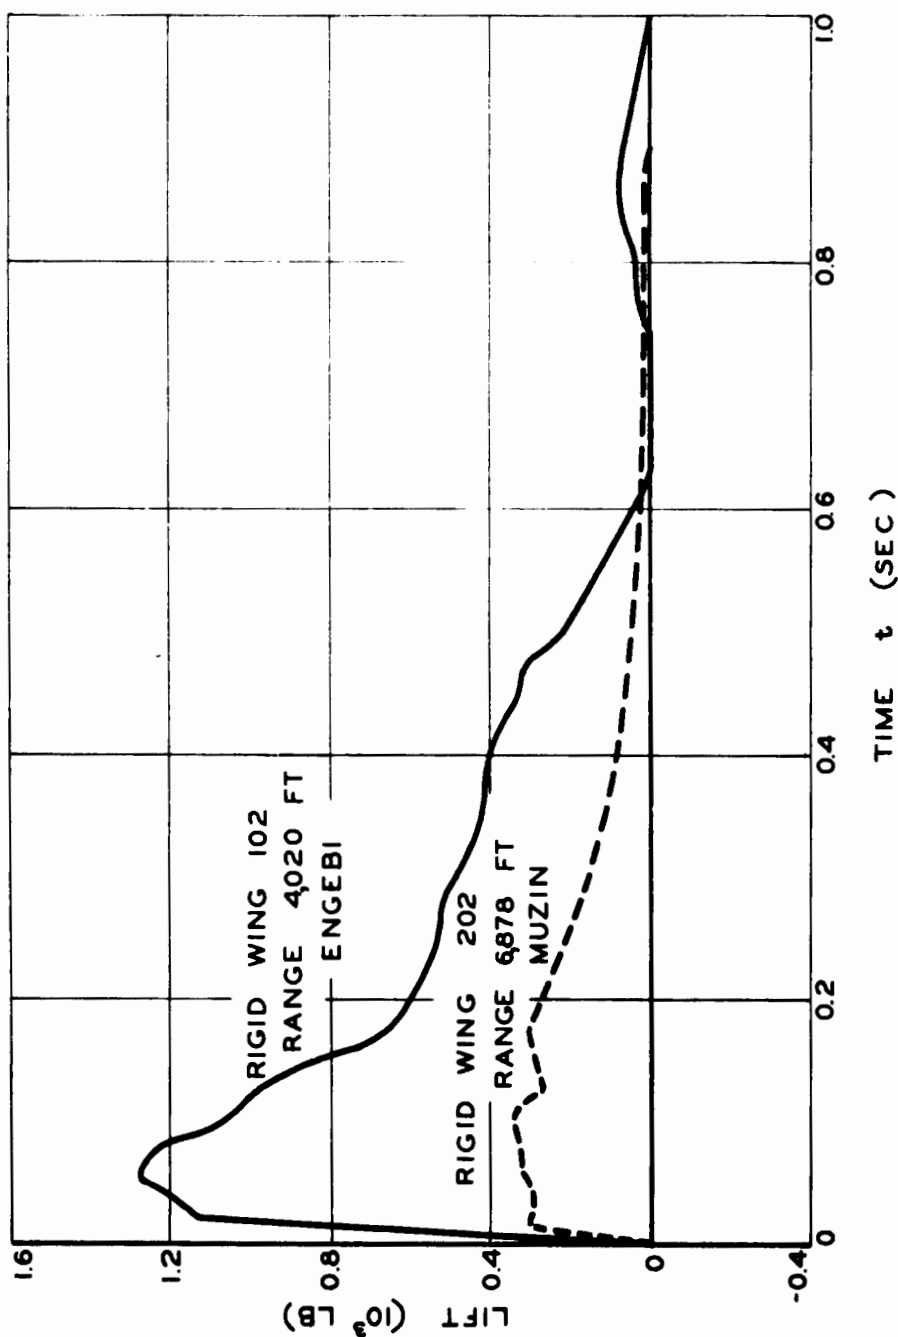
Fig. 5.10 Average Variation of Lift with Time, Obtained from Balance-system Measurements for Two Wings. Each had  $9^\circ$  angle of incidence, at different ranges.

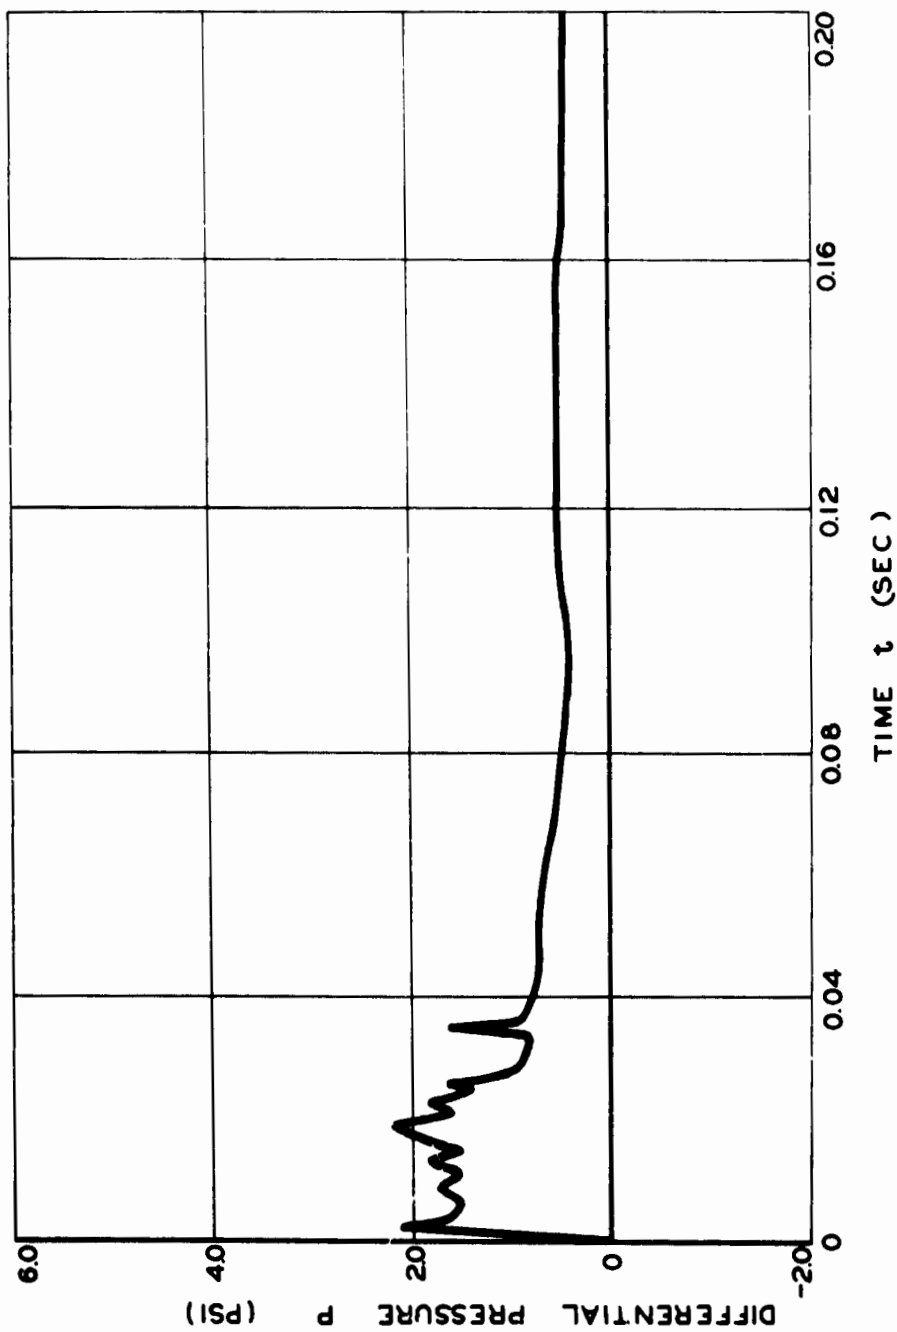
Fig. 5.14 Variation of Differential Pressure with Time at 40 Per Cent Chord of Rigid Wing 102. The angle of incidence was 9°, and the range was 4,020 ft, Engel.

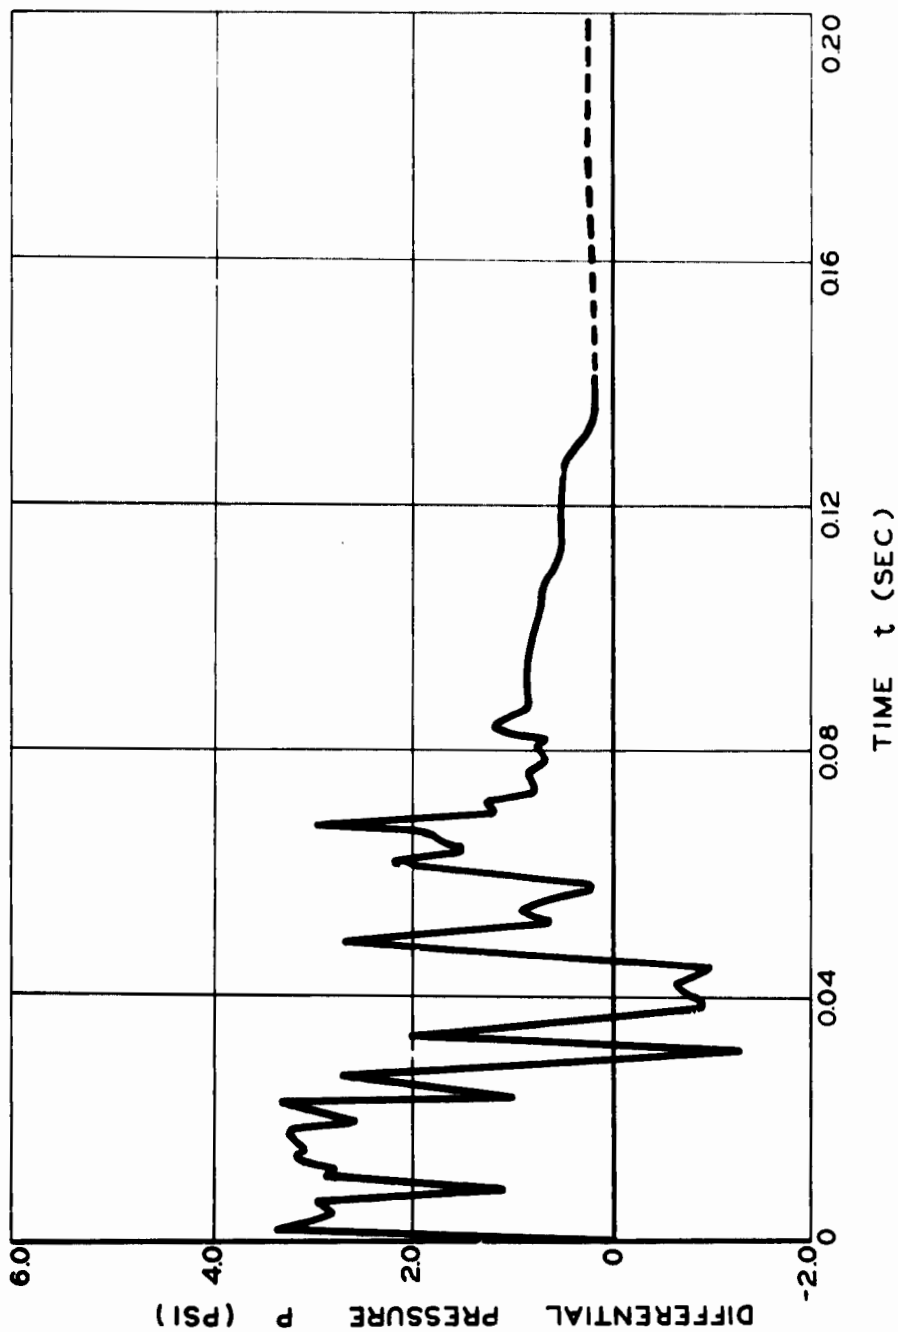
Fig. 5.17 Variation of Differential Pressure with Time at 10 Per Cent Chord of Rigid Wing 103. The angle of incidence was  $6^\circ$ , and the range was 4,020 ft, Englebi.

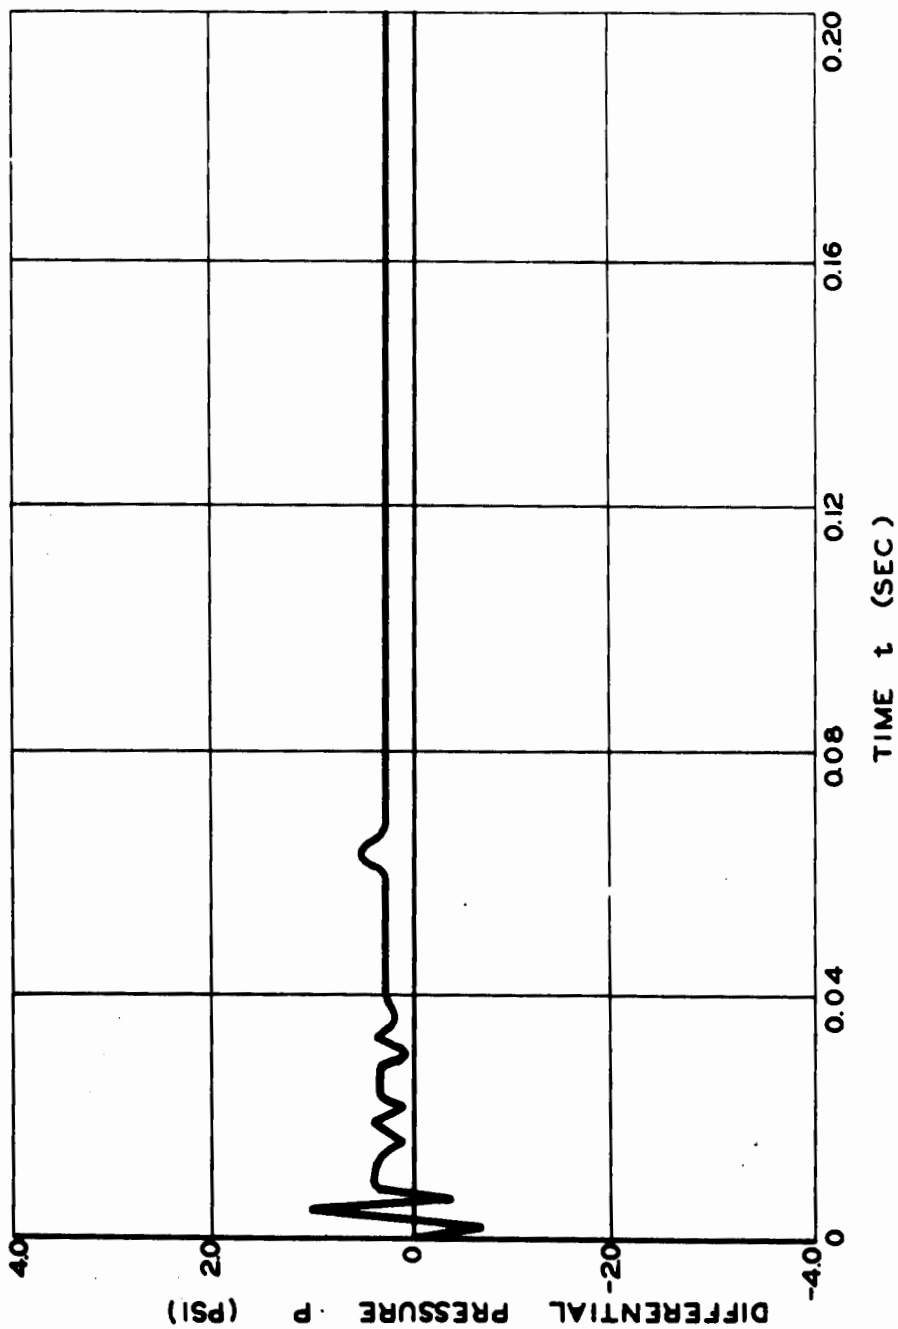
Fig. 5.21 Variation of Differential Pressure with Time at 20 Per Cent Chord of Rigid Wing 202. The angle of incidence was  $9^\circ$ , and the range was 6,878 ft, Muzin.

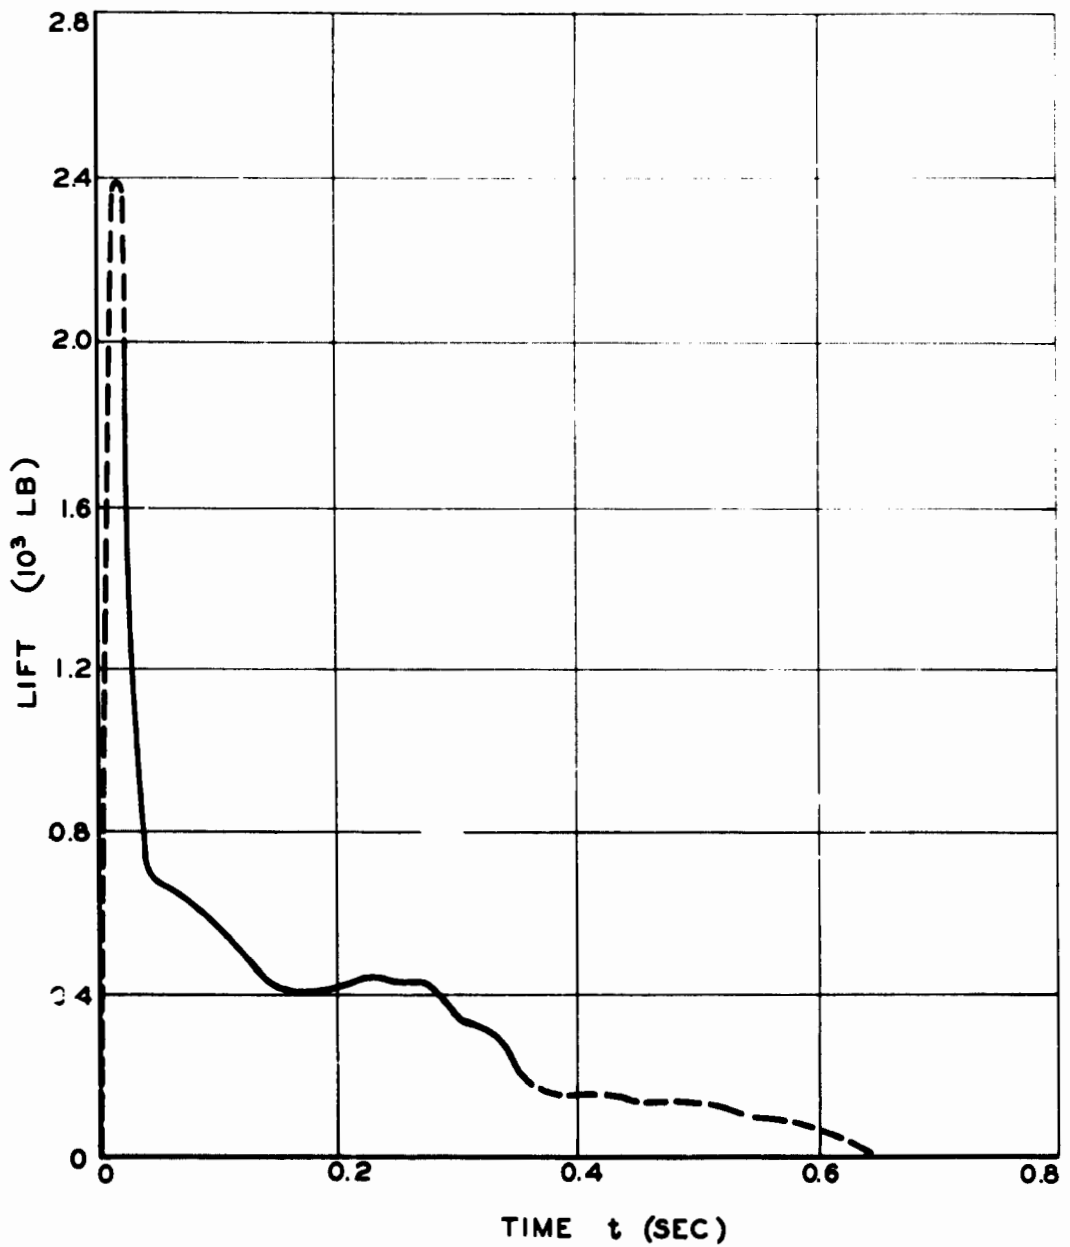
Fig. 5.25 Average Variation of Lift with Time Obtained from Differential-pressure Measurements for Rigid Wing 102. The angle of incidence was  $9^\circ$ , and the range was 4,020 ft, Engel.

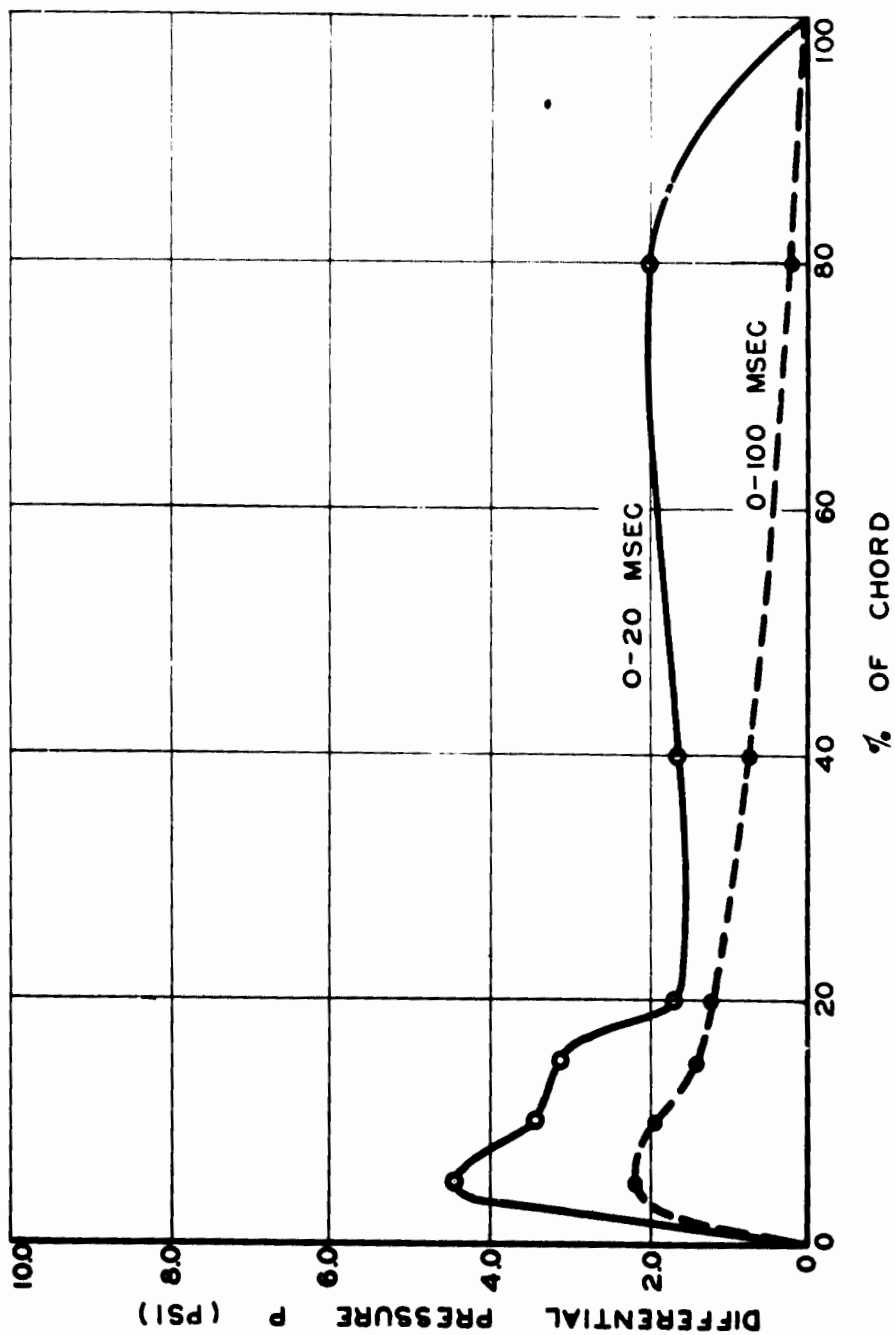
Fig. 5.27 Weighted Average Pressure Distribution following Arrival of the Blast Front, from Pressure Measurements for Four Wings Transferred and Combined to Give an Equivalent Pressure Distribution for a Rigid Wing. The angle of incidence was  $9^\circ$ , at a range of 4,020 ft.
